Five-Year Review Report

Third Five-Year Review Report for Oconomowoc Electroplating Company, Inc. Superfund Site Town of Ashippun, Dodge County, Wisconsin

July 2007

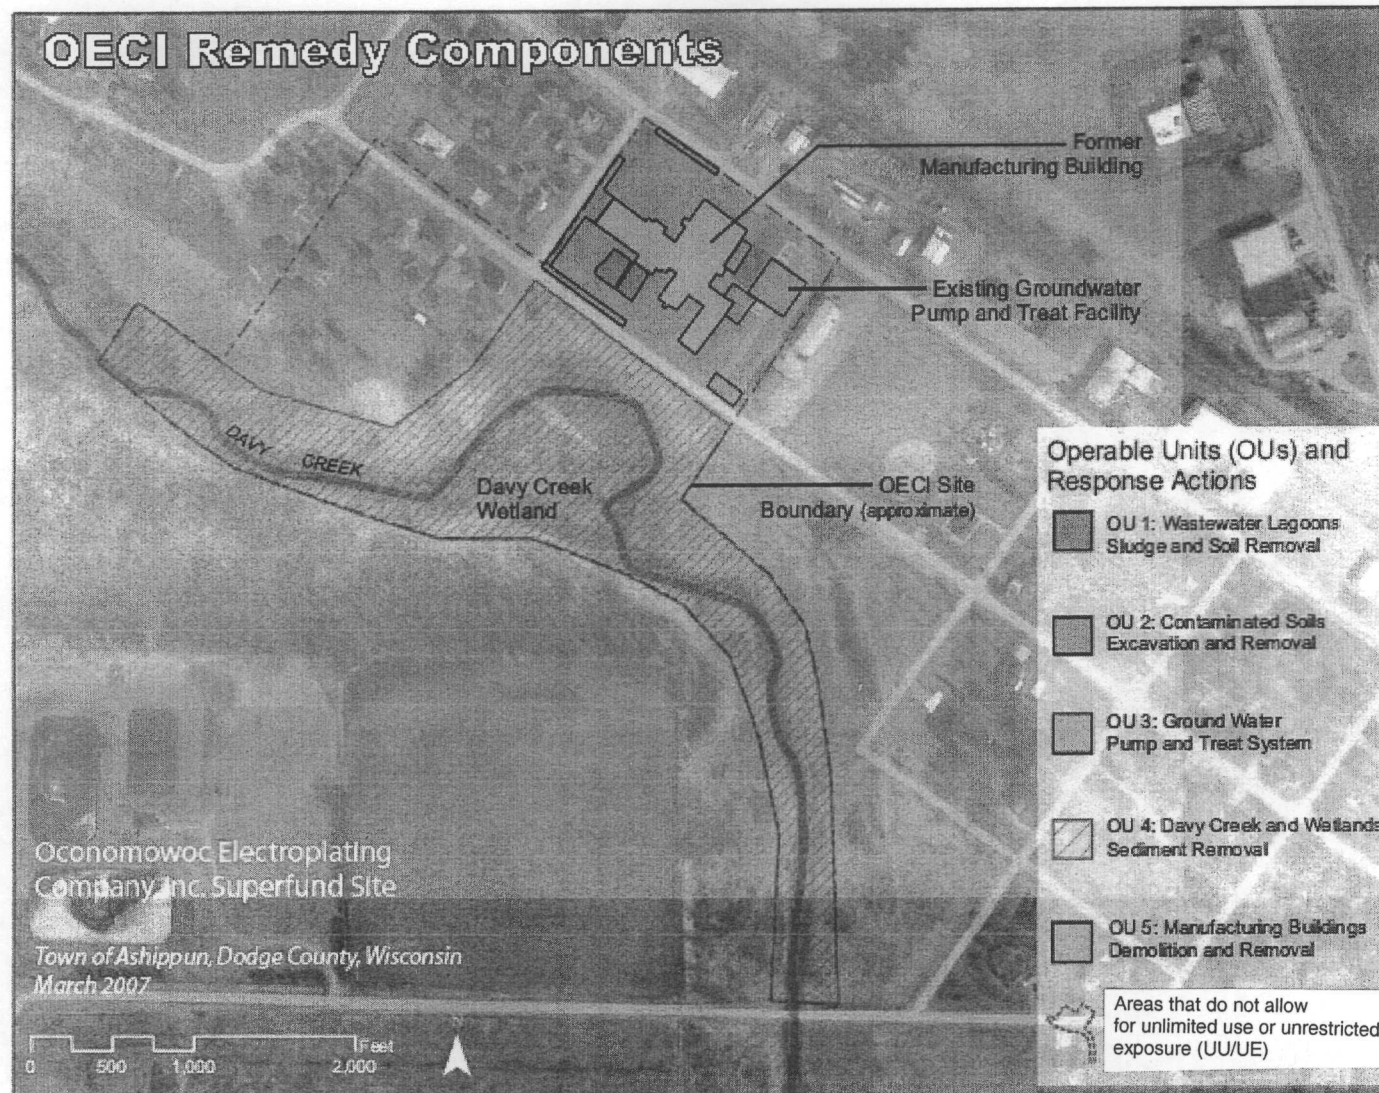
Attachment 2 aerial photograph indicating where there are areas that do not allow for unlimited use or unrestricted exposure (UU/UE).
